Inspection report for the property at
00001 Somewhere RD, San Antonio, TX 78000w

This report is prepared exclusively for **Jade Doe**
Inspected On: **04-23-2025**

Allied Real Estate Inspections, PLLC

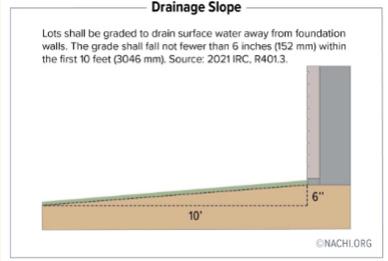
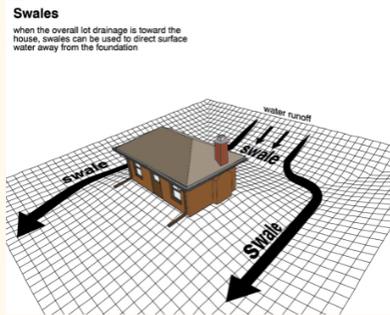
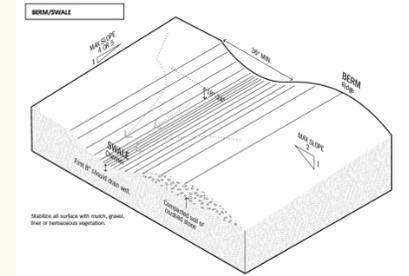
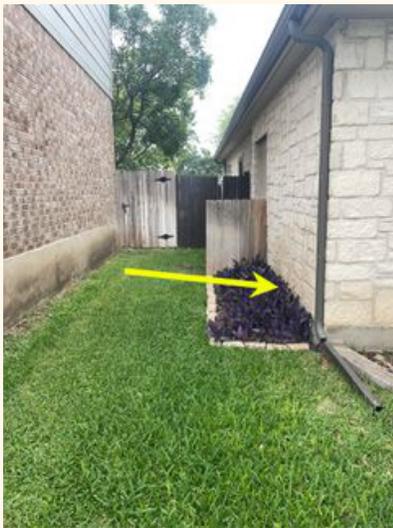
Grading Deficiencies: Slope-Neg to Neutral grade

(SS-3) Suggested Repairs: **The exterior grading had an area(s) that sloped towards the foundation (negative grade) or level areas (neutral or no grade) which may allow**

ponding near, or direct rain runoff to, the foundation. Both conditions allow rain water runoff to drain toward or collect in pools at or near the foundation which raises the moisture level in the soil supporting the foundation. Elevated soil moisture levels can effect the foundations ability to support the weight of the structure (load bearing capacity).

Grade on the south side moves run-off toward the foundation. Other sides had appropriate grading.

Swales should slope toward to the front or rear of the home with no standing water collection (ponding). This is may not be able to be determined without rain events.

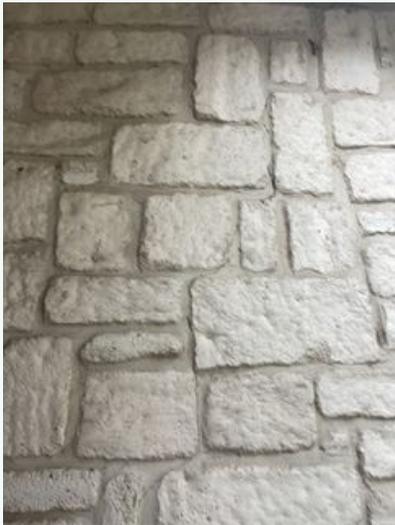
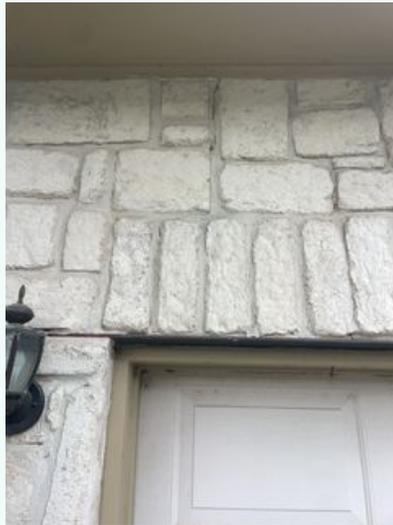
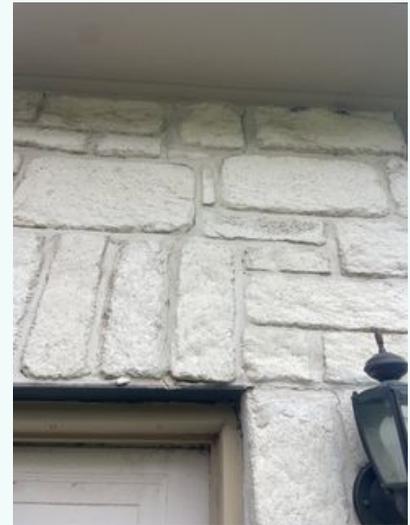
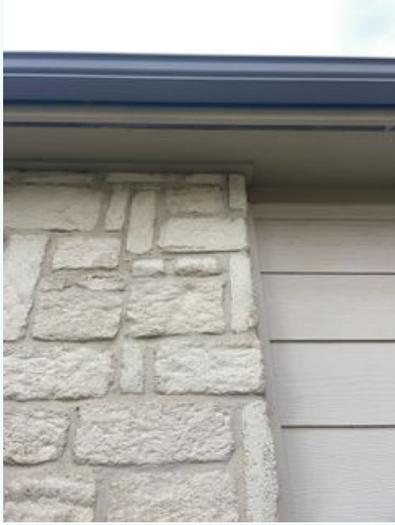
Brick / Masonry Deficiencies : Cracks less than 1/4"

**(SS-5) Monitor:** Cracks / bulging were noted in the walls. Cracking can be due to routine settlement or moderate seasonal expansion and contraction of the home. It can also be related to workmanship and or foundation movement.

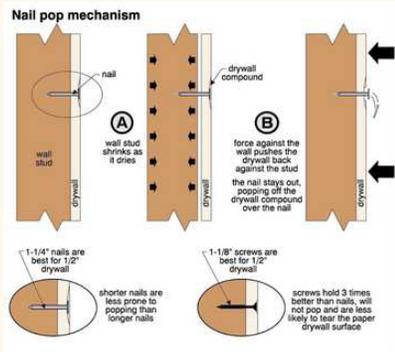
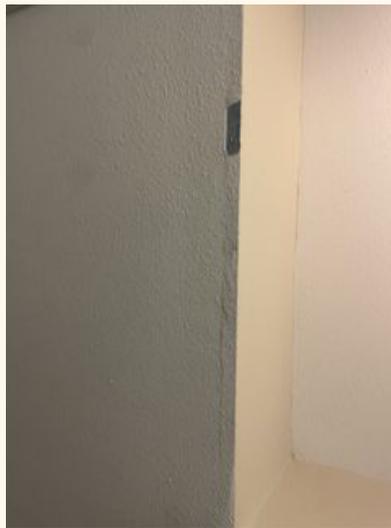
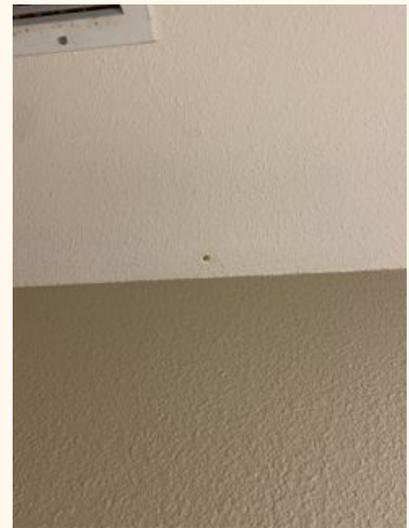
Ceiling Deficiencies: Nail pops, Garage Ceiling- loose/missing tape joints

🔧 (SS-6) Suggested Repairs: Nail pops were noted in the ceiling. The causes of this stem from framing shrinkage, settlement, and humidity changes or it can be more persistent resulting seasonal movements in the house framing. Recommend repairing these nail pops and monitoring for signs of on-going movement.

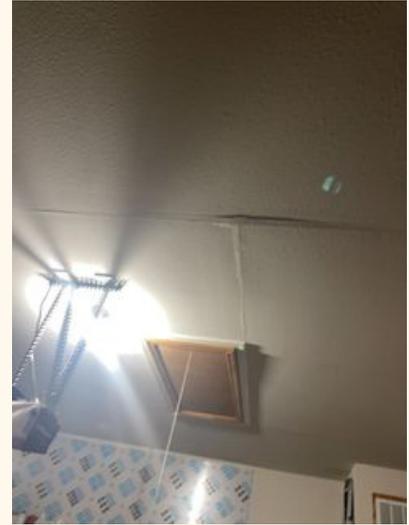
The garage ceiling and walls had cracking, loose or incomplete drywall tape joints. The walls separating the garage from the home living space **did** meet generally-accepted current safety standards for firewalls to isolate the interior of the home from the garage. Loose tape joints in the garages are common in Texas due to heat and humidity changes which cause drywall sheets to shrink and grow.

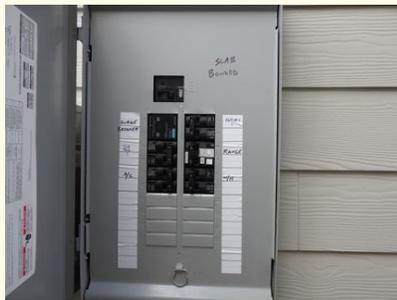
Main Panel prior to inspection

(ES-1) Improve: White (neutral) conductors inside the electric panel(s) were not identified as hot, ungrounded conductors - these should be marked (painted in black or red ink) for correct identification and improved safety.

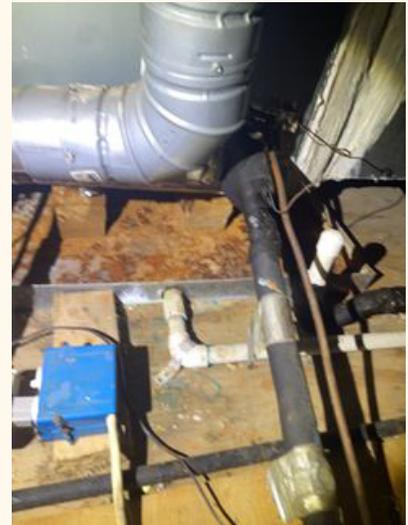
rust in drain pan. No water was present for the day of inspection. The pan looks to be water tight but with significant rust it would not be possible to know. recommend having an in line kill switch installed.

(HVACS-1) Improve: Recommend that a float or in-line switch be installed in the Furnace / A-coil overflow pan in the attic as an upgrade to shut down the unit. This helps prevent condensate overflow and water damage.

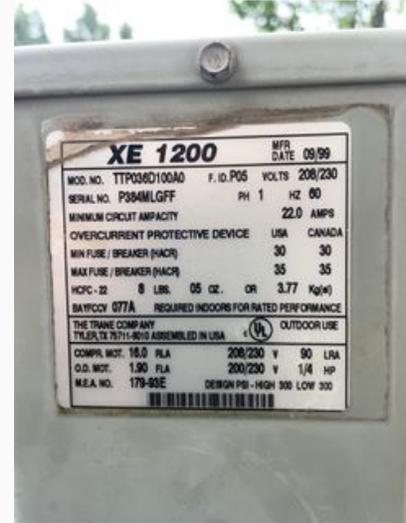
This shows the data plate for the AC unit (condenser).

AC breaker amps in tolerance: No

(HVACS-5) Suggested Repairs: The air conditioner listing plate recommends over current protection for the air conditioner compressor not to exceed **35 amps**. It appears that the air conditioner is protected by a **50 amp** breaker. Have this further evaluated and repaired as recommended by a licensed electrician to ensure the air conditioner is protected.

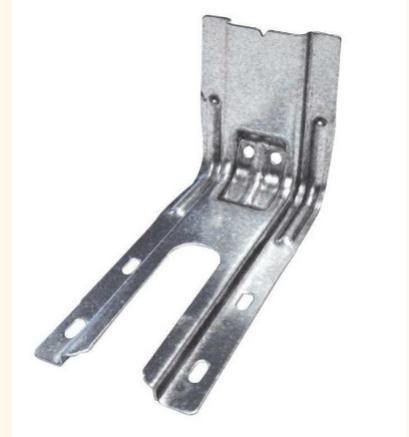
Deficiencies : No anti-tip

An anti-tip device is needed to prevent this range from tipping during operation of the oven door. This is a small clip that secures the back adjustable feet of the range to the floor and prevents the unit from tipping onto children and hot liquid spills.
