Inspection report for the property at
00001 Somewhere RD, San Antonio, TX 78000w

This report is prepared exclusively for **Jade Doe**
Inspected On: **04-23-2025**

Allied Real Estate Inspections, PLLC

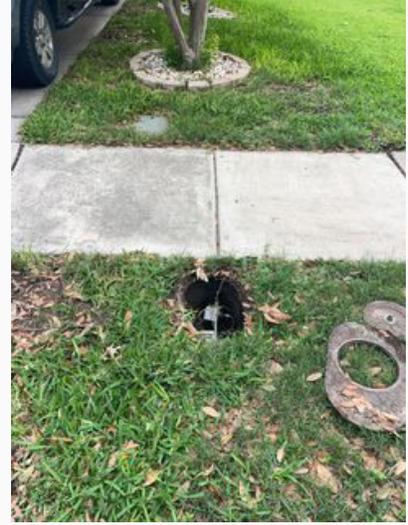
Water Meter, PRV, and Functional Flow: Photo

The photos below document the meter location and pressure reducing valve (if applicable) during inspection. The water meter was observed for 20-30 minutes with little to no changes Significant changes in water meter readings indicate that there is a leak in the system.

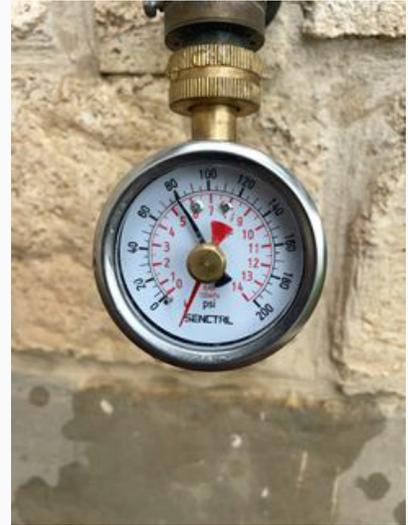
📄 (PS-1) Description:

This shows the water pressure tested during inspection.

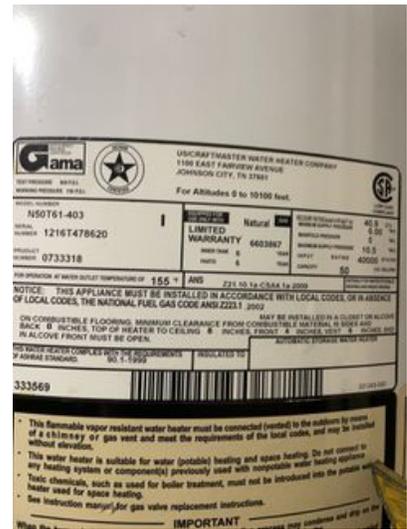
data plate

Expansion Tank: Present

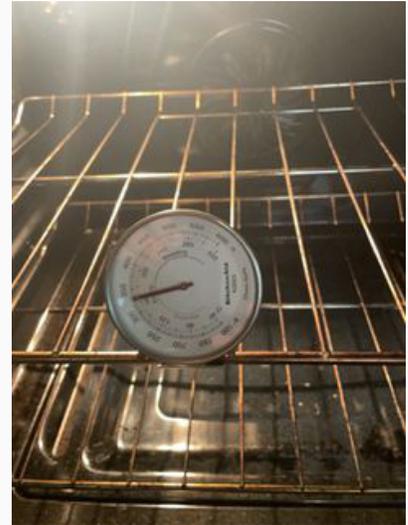
(A-3) Description:

The oven(s) was operated by placing into "Bake" mode at 350F, and the heat was produced from the burner(s) and/or elements. The oven light is tested for functionality. "Clean" options and other functions are not tested. The oven temperature is considered out of range +/- 25 Degrees per the TREC standards of practice. See the referenced number above of your system when testing.

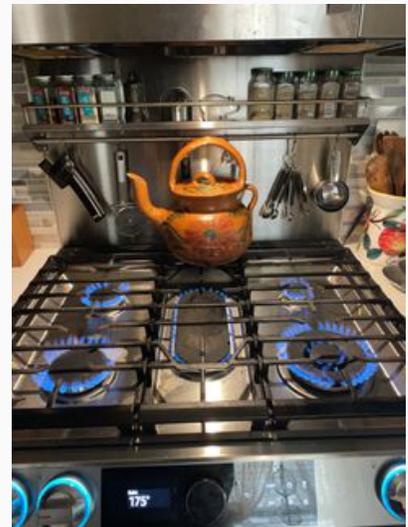
(A-2) Description:

This documents the range operation.

Deficiencies : No anti-tip

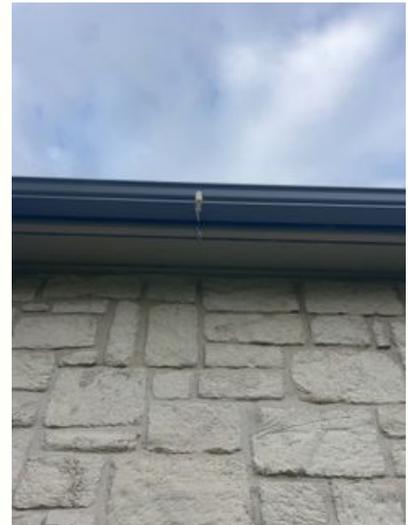
☆ (OS-1) Note:

The directive for inspection is to verify the presence of a rain / freeze sensor. Operation of the Rain / Freeze sensors is excluded from TREC inspections and out of scope. (These are required in many municipalities)
